HOUSATONIC RIVER BASIN
HINSDALE, MASSACHUSETTS

BELMONT RESERVOIR DAM
MA 00224

PHASE I INSPECTION REPORT
NATIONAL DAM INSPECTION PROGRAM

MARCH 1980

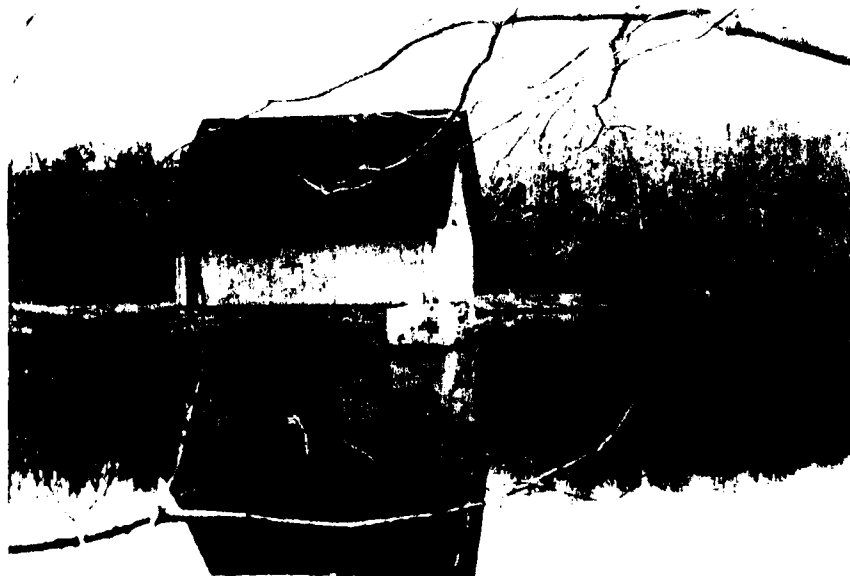
Fig. 6
Downstream face of dam
looking north from
top of slope

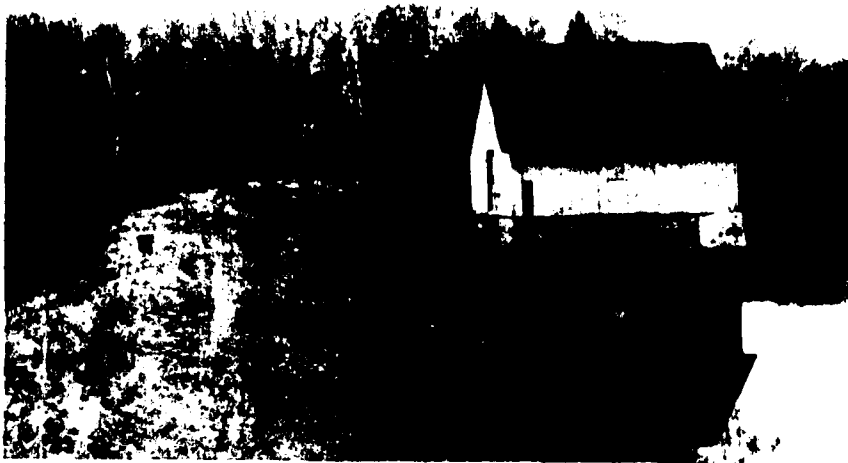
Photo 1

Dam overview looking
southerly from left
abutment

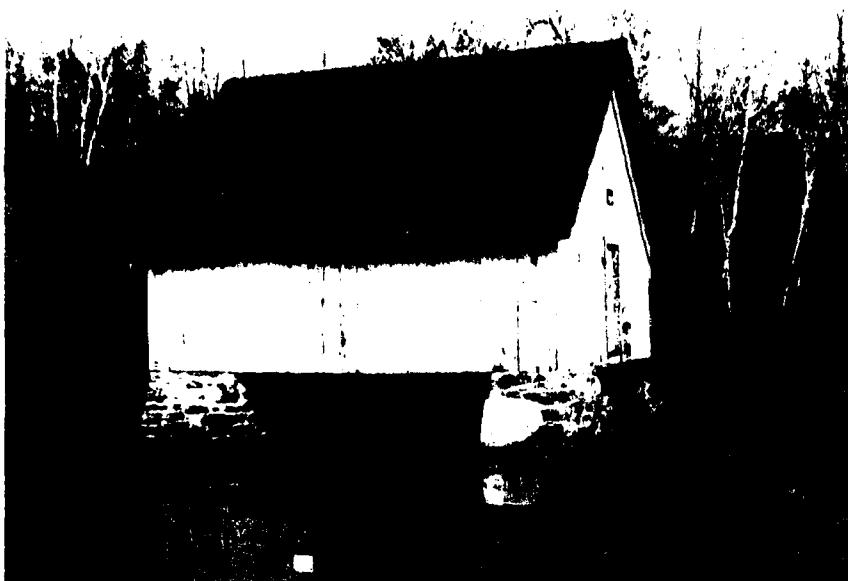
Photo 7

Gate house looking
northerly from crest
of dam
